Modal analysis of a river exploitation power house, with and without the turbine/generator units being in operation

Reto Cantieni

rci dynamics, Structural Dynamics Consultants, CH-8600 Duebendorf, Switzerland

ABSTRACT: The Eglisau River Exploitation Station has been built in the years 1905 to 1910. It is located on the Rhein River on the border between Switzerland and Germany and contains seven vertical axis Francis Turbine/Generator units. The power house is under protection as a historic monument. The owner of the power station, NOK, Nordostschweizerische Kraftwerke AG, plans to exchange the existing units through new Kaplan Turbine/Generator units. FE model calculations had shown that there might be a risk of ending up in structural vibrational problems when increasing the rotational frequency to $f = 1.85$ Hz from the actual $f = 1.39$ Hz. To allow validation of the respective model, experimental modal analyses using AVT, Ambient Vibration Testing, technology were performed. As a first attempt with the turbine/generator units being in operation failed, a second successful attempt was undertaken with the units being shut off. The paper discusses the reasons for the failure an

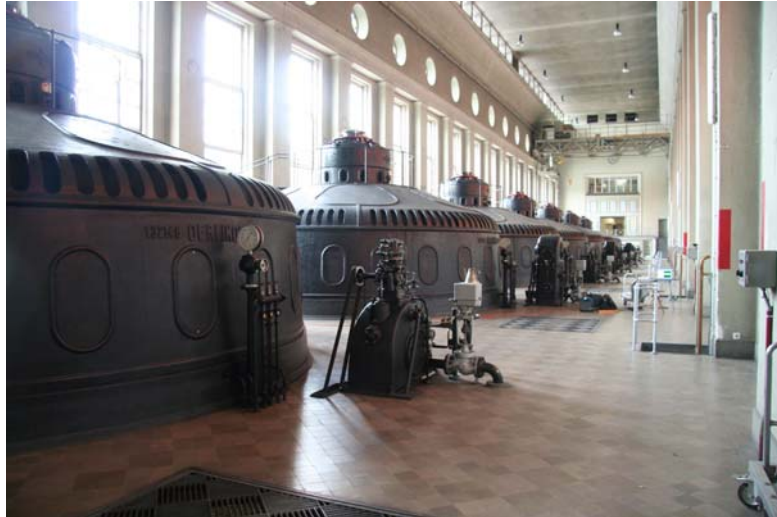
Figure 2 : View on the power house machine floor.

The Eglisau power house is a reinforced concrete structure of about 90 m in length, 17 m in width and 45 m in total height (Fig. 1). It contains seven vertical axis Francis turbines and generators. Figure 2 gives a view into the machine house. We call the visible floor "machine floor" and the visible roof the "roof floor". What we can see on the machine floor are the covers of the seven generators. Underneath the machine floor, there is the so-called "turbine floor" which the top of the turbines is fixed to. The turbines themselves are located below the turbine floor where the power house is founded in rock (Fig. 3).

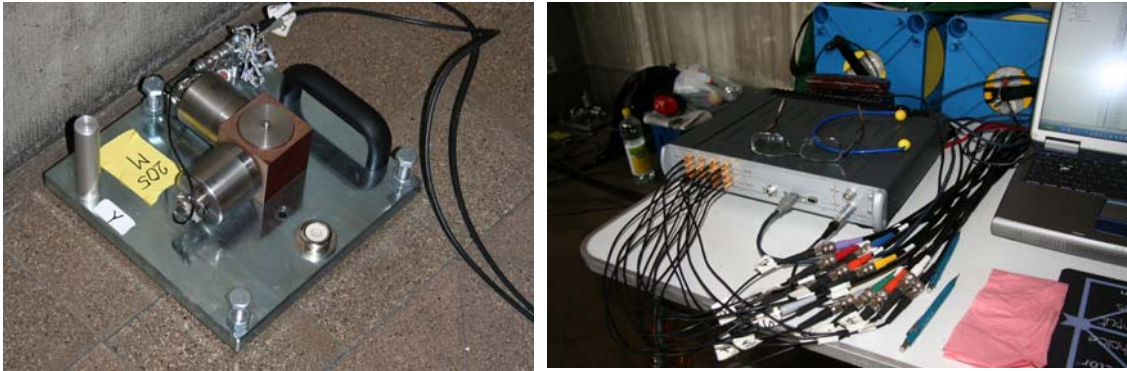
Figure 6: A 2DOF- Sensor support (left) and the measurement center (right).

The accelerometers used were of the PCB 393B31 type (10 V/g sensitivity) and the data was acquired using an LMS Pimento frontend (24 bit resolution) and a laptop computer (Fig. 6).
